Manhole Inspection Summary

Manhole # S15II1002MH

Location Address: **4209 ROLAND VIEW AVE**

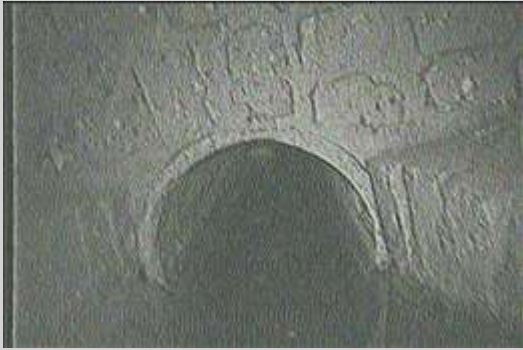
8 in. Circular Gravity Sewer

Rod and Bar (Angled)

Pipe Material: **Clay** ☐ Pipe Lined

Infiltration: **None** Pipe Seal Cond: **Unknown**
